CALSPAN ON-SITE AIR BAG DEPLOYMENT INVESTIGATION

CALSPAN CASE NO. 94-23

**VEHICLE #1 - 1993 CHEVROLET CORSICA LT (AIR BAG-EQUIPPED)
VEHICLE #2 - 1986 CHEVROLET CELEBRITY STATION WAGON**

**LOCATION - STATE OF MASSACHUSETTS
CRASH DATE - [REDACTED], 1994**

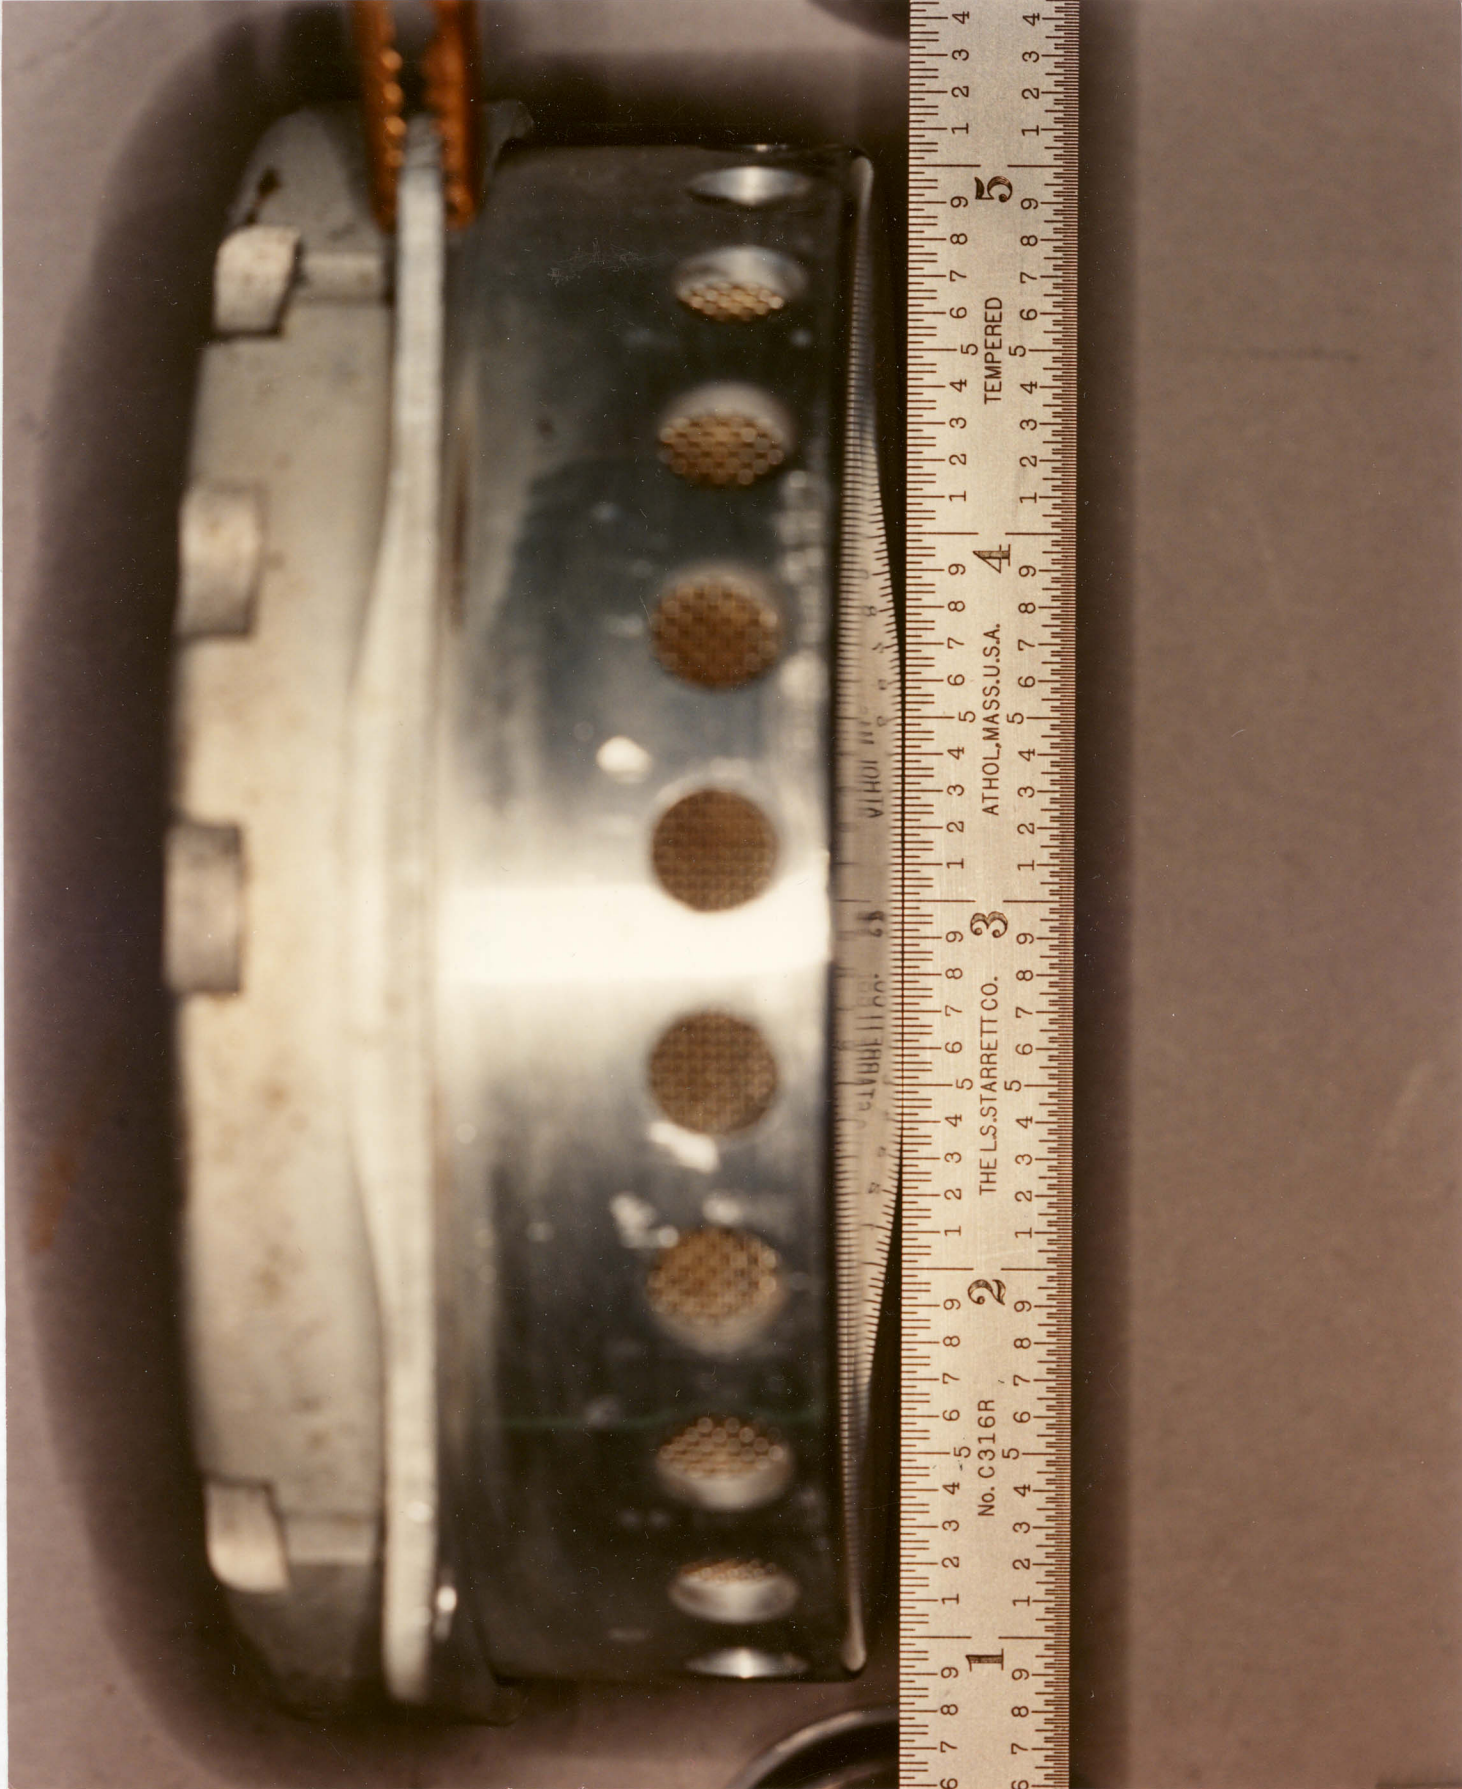
Interior damage to the Chevrolet Corsica LT was associated with the air bag deployment and occupant contacts. The air bag module cover opened along the designed seam lines in the typical "H" pattern configuration. During the deployment sequence, the igniter weld land inside the inflator unit failed which caused the inflator housing (i.e., the base and diffuser surfaces) to deform outward (i.e., bulge) from its original shape.

102. Side view of the inflator showing the distortion ("bulge") of the diffuser surface in relationship with a calibrated scale.

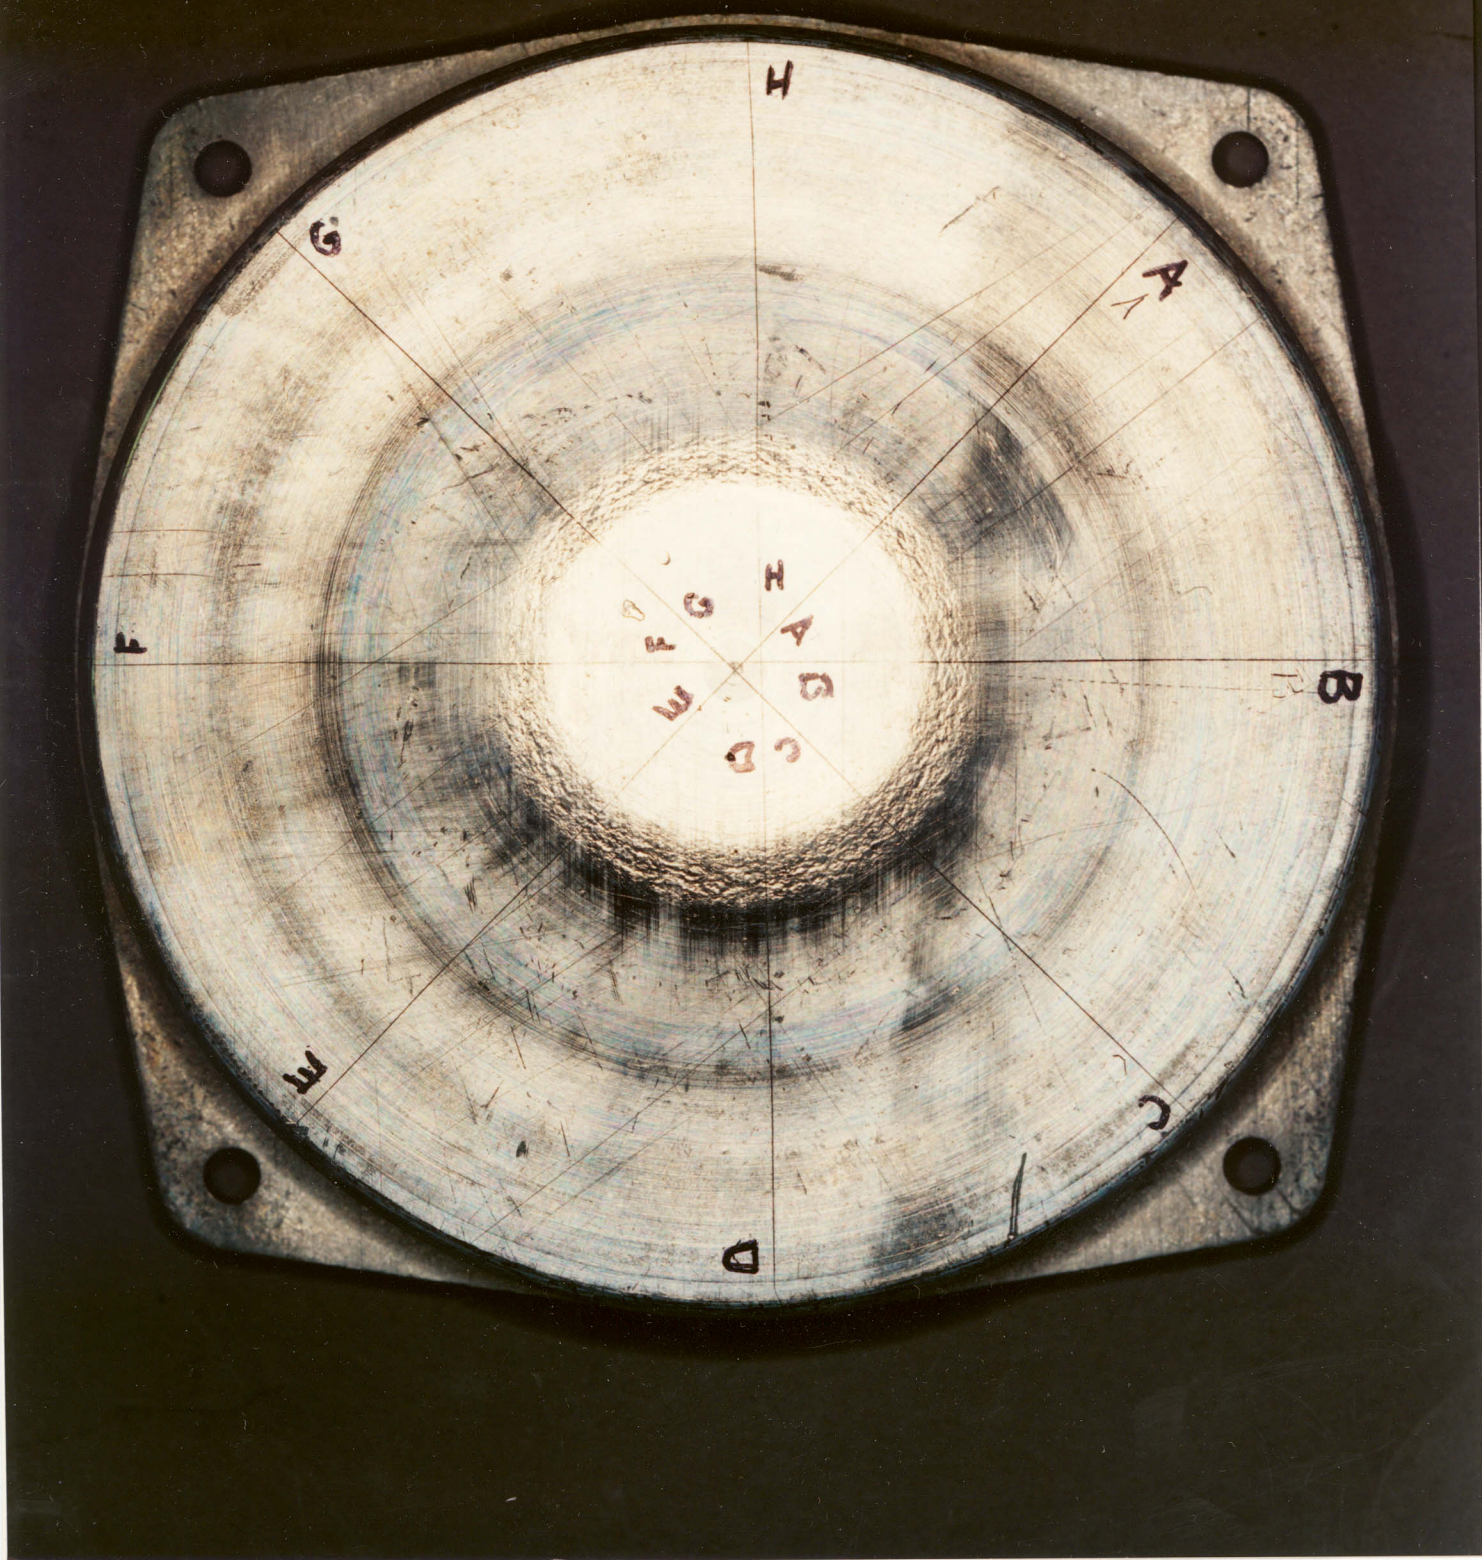
103. View of the diffuser side of the inflator with reference axes established. Note the circumferential stress marks near the center of the unit.
